National Transportation Safety Board

Marine Accident Brief

Fire on Board Passenger Vessel *Safari Spirit*

Accident no.	DCA-12-LM-016
Vessel name	<i>Safari Spirit</i>
Accident type	Fire
Location	Pier 9, Fisherman's Terminal, Seattle, Washington 47°39.385' N, 122°22.896' W
Date	April 27, 2012
Time	0100 Pacific daylight time (coordinated universal time – 7 hours)
Damage	Est. \$1.5 million
Injuries	None
Environmental damage	None
Weather	Winds southerly at 10 knots, air temperature 45° F, sky overcast, visibility good
Waterway characteristics	Fisherman's Terminal, a marina near the Lake Washington Ship Canal about 1.5 miles east of Puget Sound

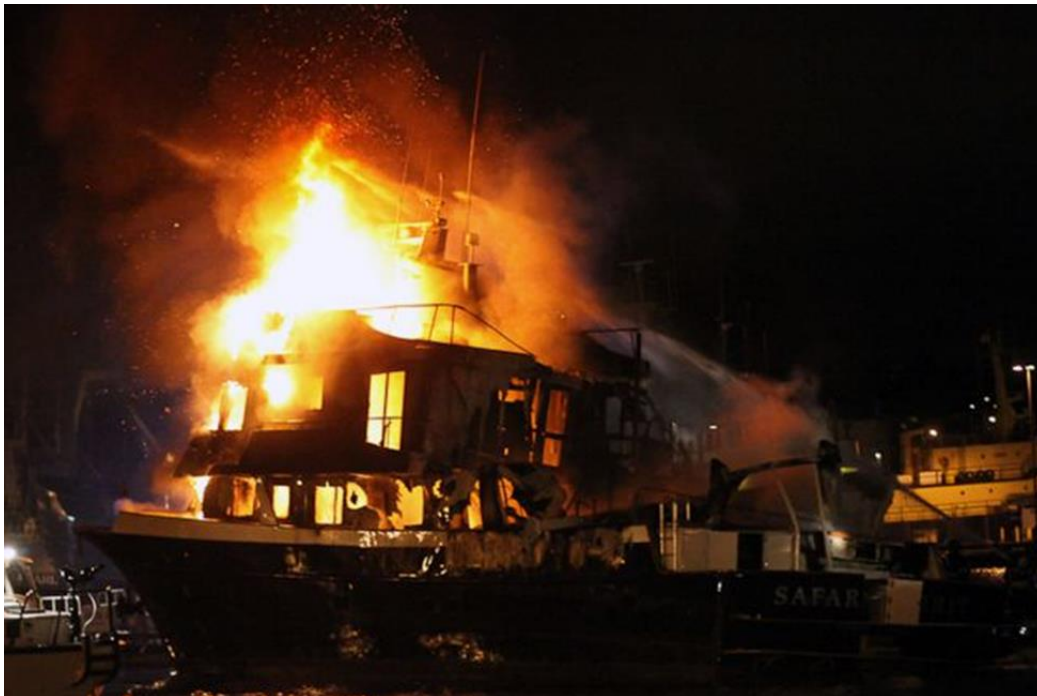
Safari Spirit ablaze at Fisherman's Terminal in Seattle, Washington. (Photo by Joshua Lewis, KOMO News)

The fire was estimated to have started at about 0100, with the Seattle Fire Department arriving shortly thereafter and extinguishing the blaze. The bow of the vessel was pointed north and the ignition location was on the aft deck, so the southerly 10-knot wind helped to push the flames forward on the vessel. The forensic fire investigation concentrated on the self-heating of the flammable oil and paint cans left on the aft decks in the area of the freshly oiled decks. (See box at right on self-heating and fire ignition for more information.) However, no final determination was made regarding the source of ignition of the fire.

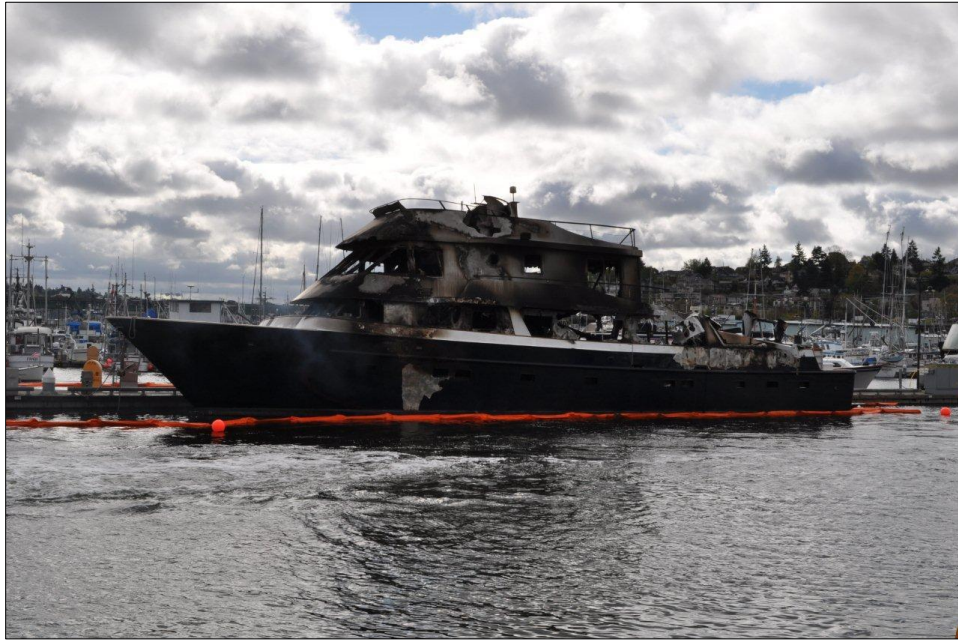
A marine survey estimated the cost of rebuilding the vessel to be \$4 million. A pre-fire fair market value survey in January 2011 estimated the value of the vessel at \$1.5 million.

Charred wreckage of the *Safari Spirit*. (Photo from Bowditch Marine, Inc.)

The National Transportation Safety Board determines that the fire aboard the passenger vessel *Safari Spirit* ignited due to unknown causes and was accelerated by the flammable materials stored on the aft portion of the main deck.
